# ATF Cooler Failures Stump Everyone

CJ Readers invited to weigh in...

***Editor's Note:** This article addresses an unusually frequent and perplexing product failure for which no one seems to have answers. For years, and with surprising frequency, in-tank automatic transmission coolers used on a variety of heavy duty work trucks, especially snow plows, dump trucks and refuse haulers, as well as some school buses and RVs have failed catastrophically as shown in our cover photo and in the article below. No definitive cause for these failures have been found, which has left vehicle and transmission manufacturers and cooling system distributors and repair specialists debating the potential causes, and dealing with warranty returns, associated costs, and the frustrations of not being able to identify a root cause for the problem.*

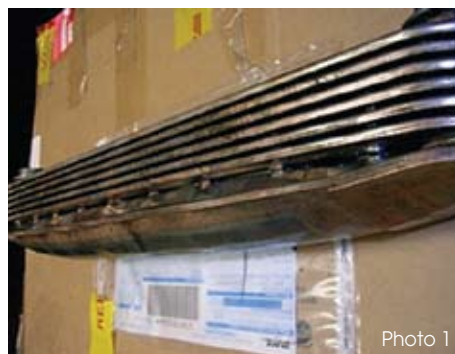
Photo 1 shows a 7 plate, 18 inch, in-tank transmission cooler which experienced a catastrophic failure early in its service life and was returned to the distributor. Note the ballooning of the plate located toward the bottom of the cooler as shown in Photo 1. This plate deformed almost across its entire length. Also pres-

ent in the ballooned portion of the cooler was a one inch crack located about 1 mm from the side flange.

The ballooning of the plate suggests that the cooler was exposed to excessive internal pressures which caused the plate to bulge outward. Such a failure should be an extremely rare occurrence. Unfortunately, it doesn't seem to be. Many cooling system specialists have run into this type of failure quite often and such cooler failures have become a serious issue for the entire industry.

It seems obvious that excessive pressure is the likely cause of the bulging of the bottom plate as shown in the cooler returned by the customer. But how did pressure, sufficient to deform 304 stainless steel, get into or build up within the ATF cooler and/or the transmission itself?

The cooler that failed in the field was also sent out for examination to determine if corrosion was involved in the formation of the fracture. The examination, conducted by another third party testing company found, "There was no discernable corrosion activity in or near the fracture."

The report concluded, "This workup raises the possibility that much higher internal pressures (*Ed. - well over the normal operating pressure*) may be required to cause this failure without factoring in the strength imparted to the union of the turbine to the stainless casing. The possibility of unexpectedly high internal pressures in the cooler should be given due consideration in any root cause analysis."

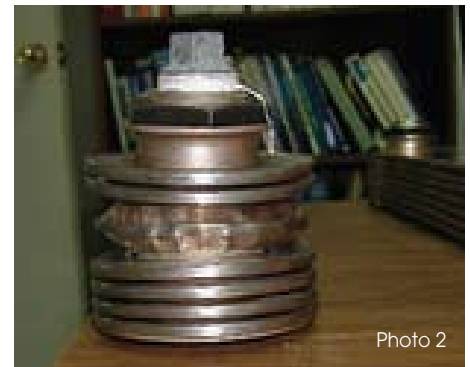
Photo 2

The first cooler was then filled with transmission fluid, pressure gages at inlet and outlet were calibrated, and the high pressure line was attached to the inlet fitting. At an ambient temperature of approximately 75°F (23.8°C), the pressure was steadily increased from 0 psi upward at 20-50 psi increments. At approximately 1400 psi, the oil cooler yielded at the second plate underneath the outlet fitting. As shown in Photos 2 and 3, the stainless steel plate had ballooned in a linear front across the three inch width and extended for about 1 inch along the plate.

While the cooler did not leak, it certainly exhibiting the ballooning found in the failed cooler.

Second, at ambient temperature, the high pressure test determined that cooler plates such as these will fail at approximately 1400 psi. We know that the internal pressure inside a transmission should never reach 1400 psi, but both the failed cooler from the field and the test coolers from the high pressure and high temperature/high pressure tests exhibited the same kind of ballooning suggesting that somehow, really excessive amounts of pressure may have gotten into the transmission.
